Reference: This service bulletin replaces the previous service bulletin SB 85-0017 from April 2001, which should be discarded.

Power seat, tilt-travel-forward function, repair

Model	Factory	Chassis No.
C70	J

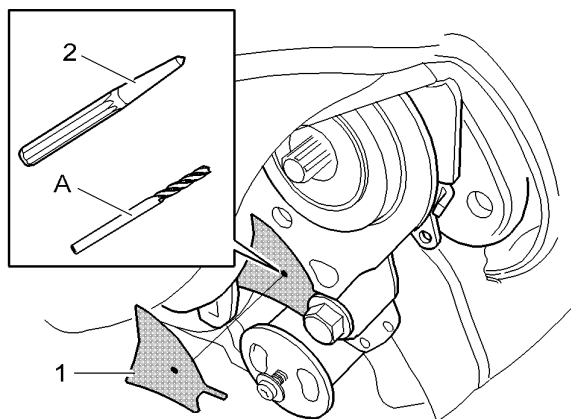
D8503881

If the travel-forward function of the front seats is not responding when tilting the backrest forward, as when entering the rear seat, the repair procedure described in this service bulletin should be performed.

Preparing the spring mounting

- Move the seat as far forward as possible.
- Raise the rear edge of the seat to the maximum position.
- Remove the control panel according to the method in VADIS.
- Fold up the upholstery to access the tilt mechanism.
- Make a template (1) for the side that is to be repaired. See step 3.
- Place the template on the tilt mechanism.
- Use a center punch (2) and transfer the mark in the center of the template to the tilt mechanism. Drill out the mark. Use a **3.5 mm (1/8")** drill bit (A).
